# Manhole Inspection Summary

Manhole # S31UU\_040MH

Insp Date: **5/9/07 10:56 AM**

**Location** Address: **301 29TH ST**

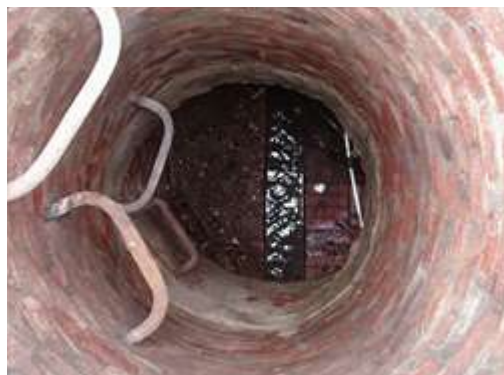
Top View

Corroded steps. Bench debris.

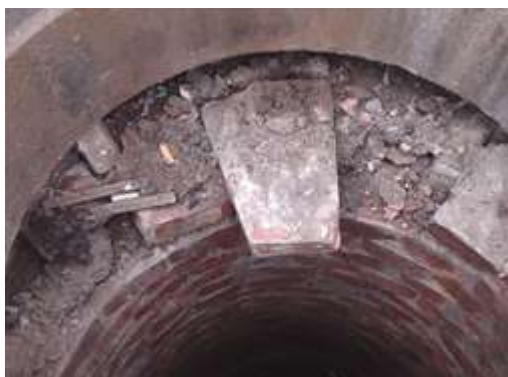
Defect

Frame leaks. Adjustment deterioration, loose brick and infiltration. Barrel infiltration.

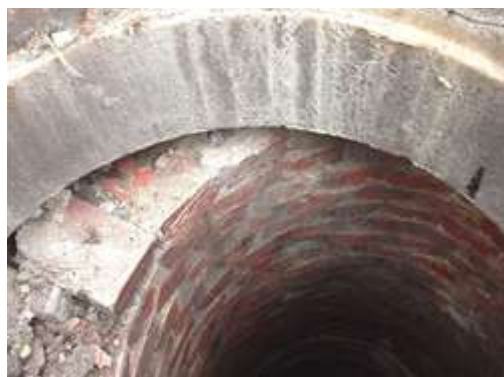
Defect

Frame leaks. Adjustment deterioration, loose brick and infiltration. Barrel infiltration.

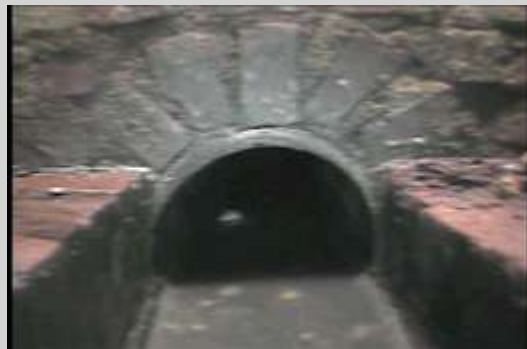
Pipe In @ 6 O'Clock

Deposits: ☐ None ☒ **Mud** ☐ Sludge ☒ **Debris** ☐ Grease

Silt Depth: **0.5** (in.)

Deposits Extent: **Light**
